Pocono Environmental Education Center Campus Restoration

Environmental Education Center
Campus restoration; 38 acres

Delaware Water Gap National
Recreation Area,
Northeastern Pennsylvania

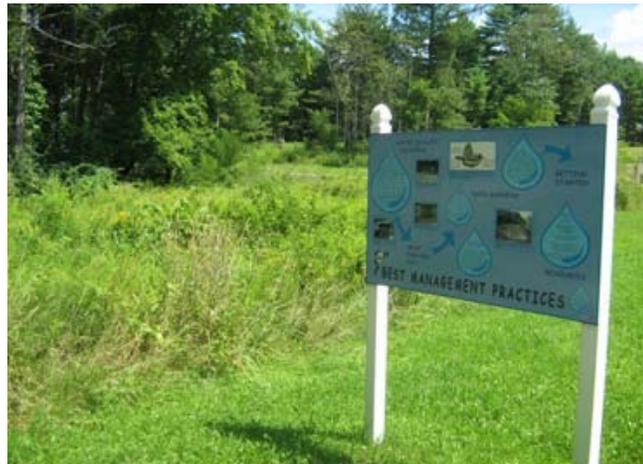
One of the rain gardens on campus

Throughout the site, rain gardens were constructed to manage and filter runoff from the campus. Runoff is being controlled further by improvements made to the grade of the paved surfaces in order to prevent water from pooling on the pavement. Both to save water resources and monetary resources, recycled rain barrels were installed under many roof drains. The rain water collected is used to water the newly installed gardens.

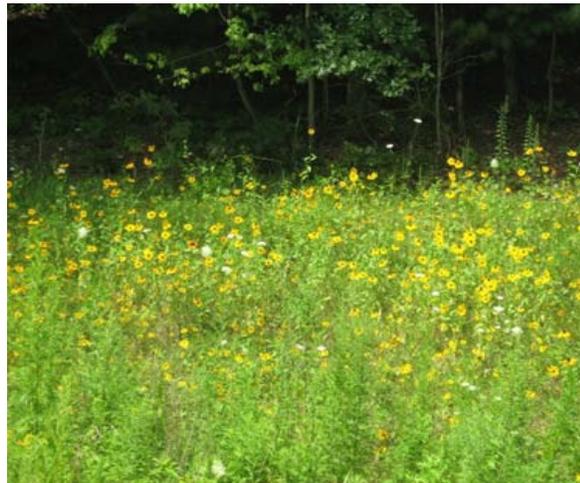
Native wildflower garden

Along with rain gardens, native wildflower gardens were constructed. These wildflower gardens establish a habitat for many species of birds. The construction of both the rain gardens and wildflower gardens serve to control erosion and water runoff. Only native plants were used in this project. Seed material for all campus plantings cost \$7,700.

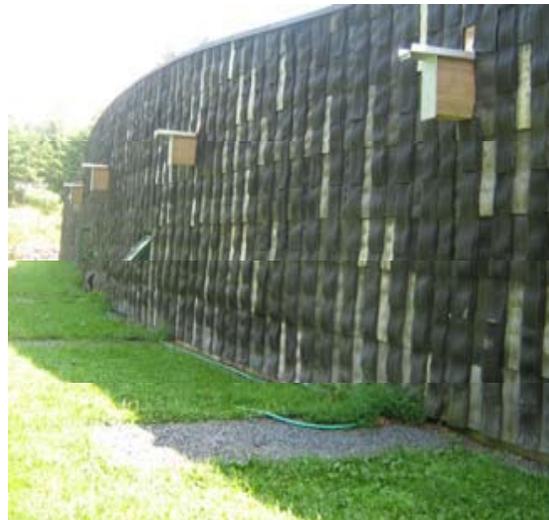
Tire siding on dining hall

side of the dining hall outside wall was replaced with recycled tire treads.
