# Blackleggs Creek Memorial Park

Rustic "Green" Park; 4 acres

Indiana County,  
Pennsylvania

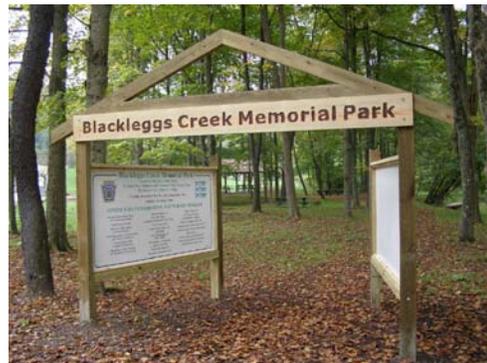
The park features a two cell, passive abandoned mine drainage system with a serene fountain that assists with keeping the water-polluting iron in the outflow from a metal or coal mine from entering the stream as well as providing visitors to the park with peaceful background sounds and a beautiful fountain as a destination. The acidic water can be extremely damaging to eco-systems and habitats that directly surround the former mine or that may be downstream. An environmental engineering firm was hired to design and permit the system consisting of a wet seal to capture the underground mine discharge, piping network, innovative aeration system, and a settling pond.

The AMD system receives regular maintenance thanks to park volunteers including only one piping repair after ten years of successful operation.

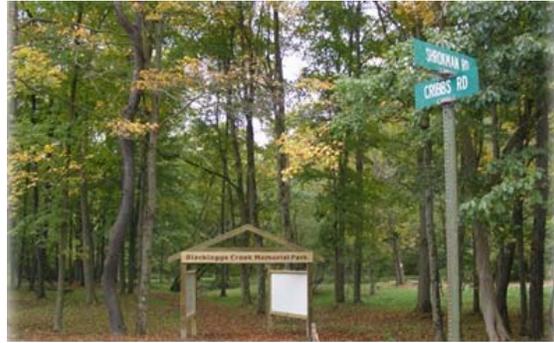
Through the park flows 500 feet of the headwaters of Blackleggs Creek, which have now been stabilized and enhanced for the development of fish habitats with assistance from the PA Fish and Boat Commission. Installed structures include over half a dozen single-log vane and multi-log vane deflectors, several root-wad deflectors, and two modified mud sill cribbing devices, all of which protect the stream banks and direct water flow back to the middle of the channel.

Surrounding the creek is a mix of native hardwood trees and riparian shrubs that not only provide enjoyable shade for park visitors, but protect the stream from the sun, keeping the water cool and well oxygenated for the fish and other aquatic life.
